DEPARTMENT OF TRANSPORTATION

Office of Structural Materials

Contract #: 04-0120F4Cty: SF/ALA Rte: 80 PM: 13.2/13.9File #: 69.28**WELDING INSPECTION REPORT****Resident Engineer:**Siegenthaler, Peter**Address:** 333 Burma Road**City:** Oakland, CA 94607**Report No:** WIR-017953**Date Inspected:** 05-Nov-2010**Project Name:** SAS Superstructure**OSM Arrival Time:** 700**Prime Contractor:** American Bridge/Fluor Enterprises, a JV**OSM Departure Time:** 1900**Contractor:** Zhenhua Port Machinery Company, Ltd (ZPMC), Changxing Island **Location:** Shanghai, China**CWI Name:** Qiu Wen**CWI Present:** Yes No**Inspected CWI report:** Yes No N/A**Rod Oven in Use:** Yes No N/A**Electrode to specification:** Yes No N/A**Weld Procedures Followed:** Yes No N/A**Qualified Welders:** Yes No N/A**Verified Joint Fit-up:** Yes No N/A**Approved Drawings:** Yes No N/A**Approved WPS:** Yes No N/A**Delayed / Cancelled:** Yes No N/A**Bridge No:** 34-0006**Component:** OBG Components**Summary of Items Observed:**

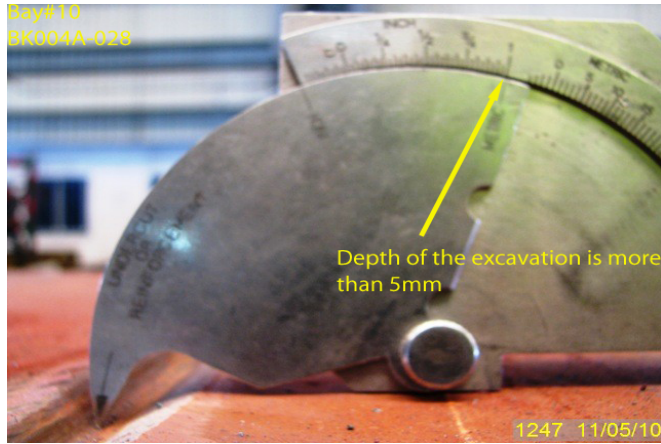
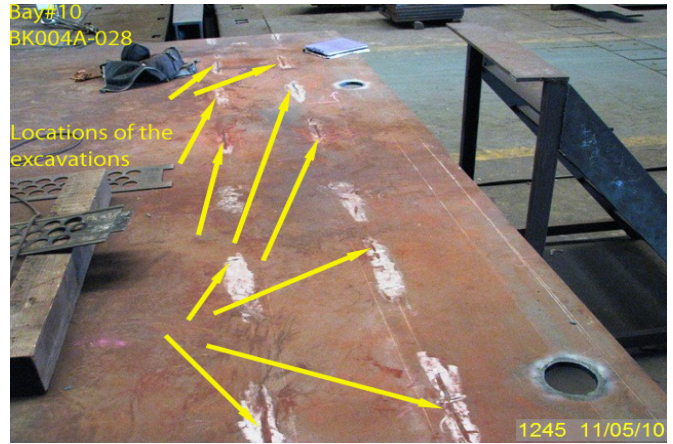
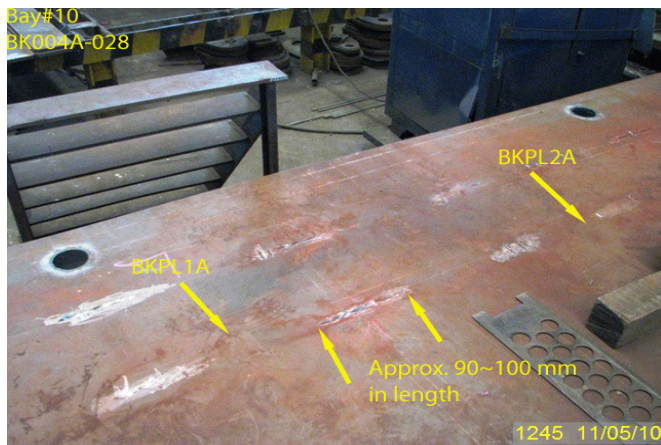
During random inprocess inspection of the Bike Path BK004A-028, This QA inspector observed that the ZPMC personnel performed Magnetic Particle testing on temporary attachment removal areas on the Top Plate. The plates are identified as BKPL1A and BKPL2A.

During MT inspection linear indications were found on all the temporary attachment removal locations. The indications were grind out by ZPMC personnel and the excavation after grinding is more than 5mm. As discussed with ZPMC QA Mr. Ken, ZPMC required submitting the critical weld repair report before performing the weld repair.
